Portage Creek Sediment Remediation Project Kalamazoo, Michigan

Pre-Sediment Removal Structure Feature Assessment Removal Areas SA5-Axtell, SA5-D and SA5-C

F&V Project Number: 809930
May, 2012

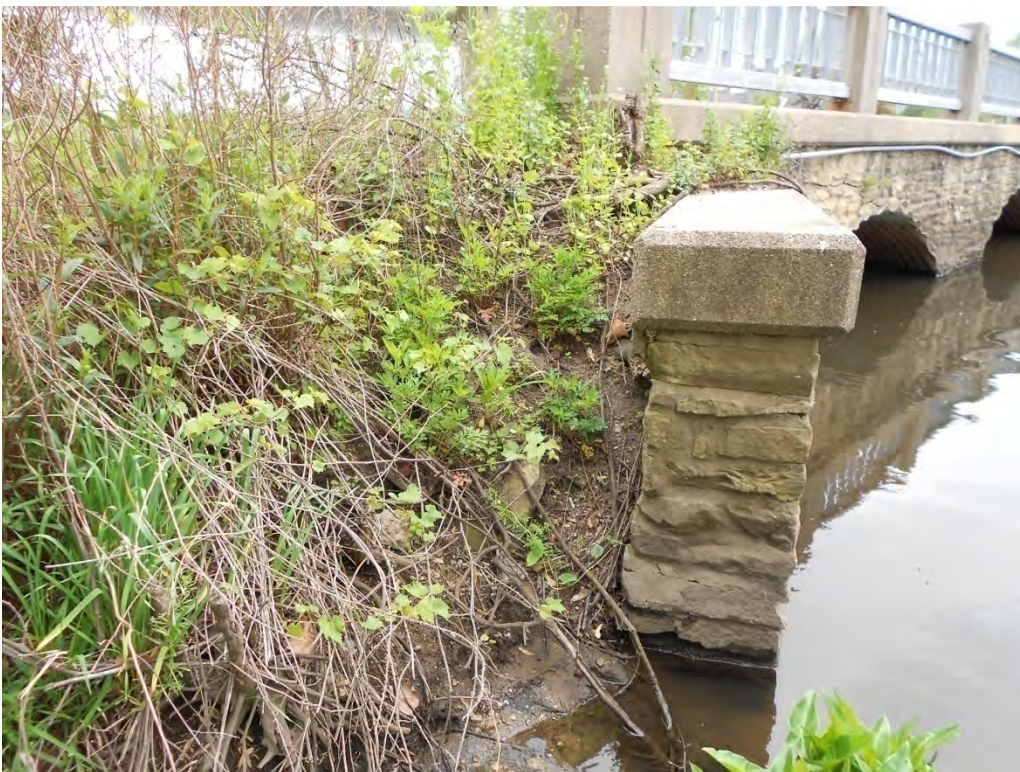
- The channel has deepened in the northeast however no footing was detected.
- Minor gaps and cracks were noted in the northeast wingwall mortar joints. The wall is overgrown with vines. Moderate erosion was noted behind the wall.

Bank erosion around northeast wingwall

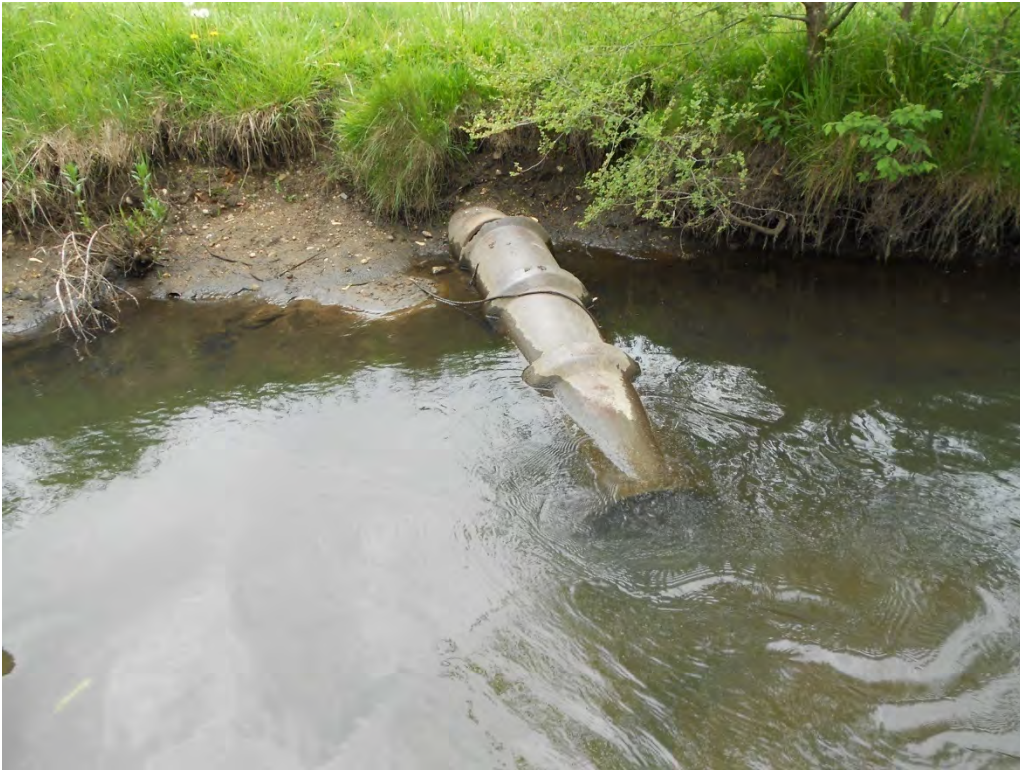
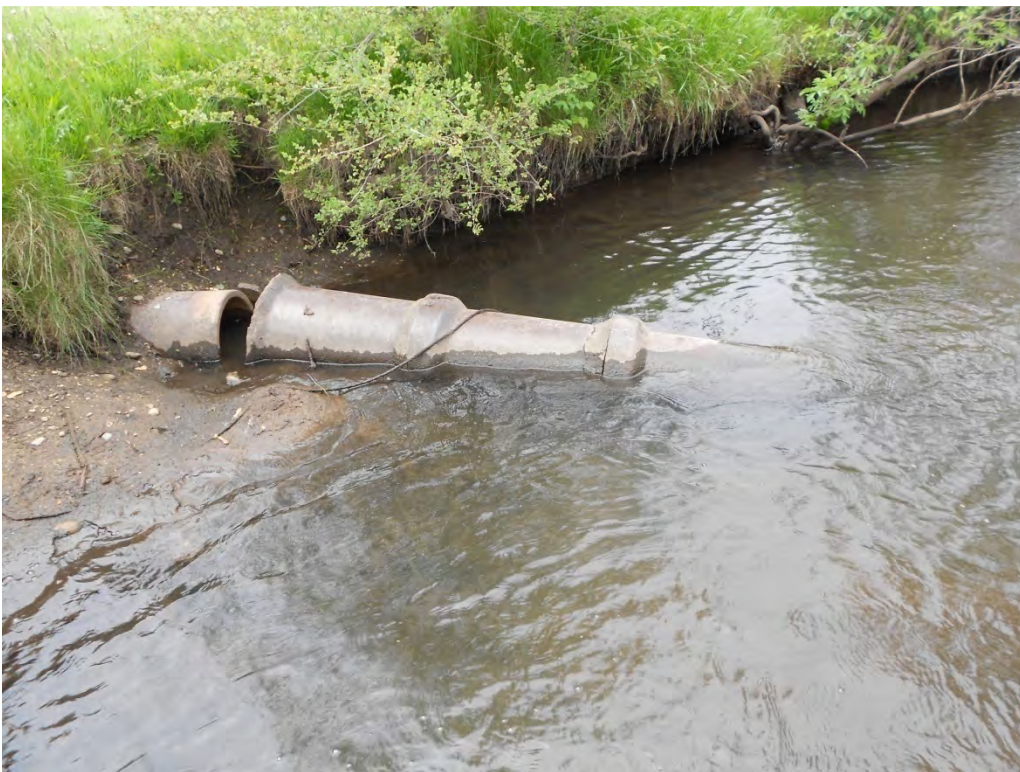
- There are 3 failed sections (~6') in the channel and the 4th exposed approximately 12" from severe bank erosion.

View of structure from the channel

View of structure from the upstream channel

- Remove the 3 failed sections. Protect the outlet with an isolation cofferdam to allow for dewatering.

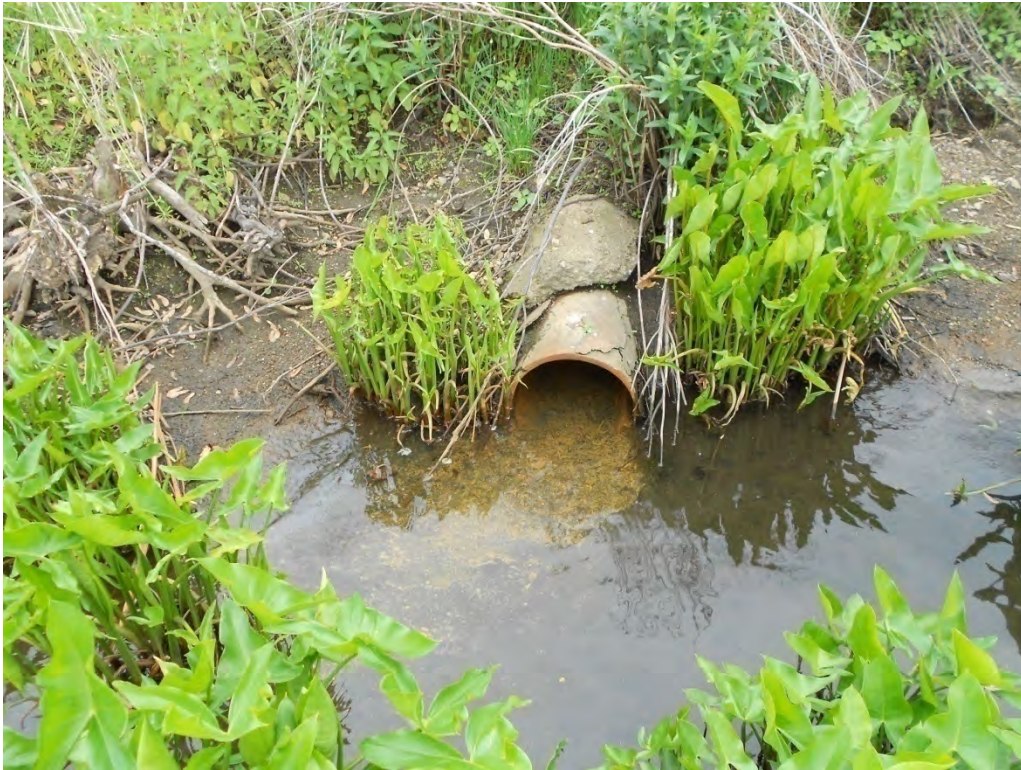
- The end of the pipe is exposed ~12" from bank erosion in the area. It is severely cracked and scaled.
- The concrete collar around the pipe is severely spalled.

View of structure from the channel

- Install a cofferdam to protect the structure and allow for dewatering. Provide approximately 2' clearance from the pipe.

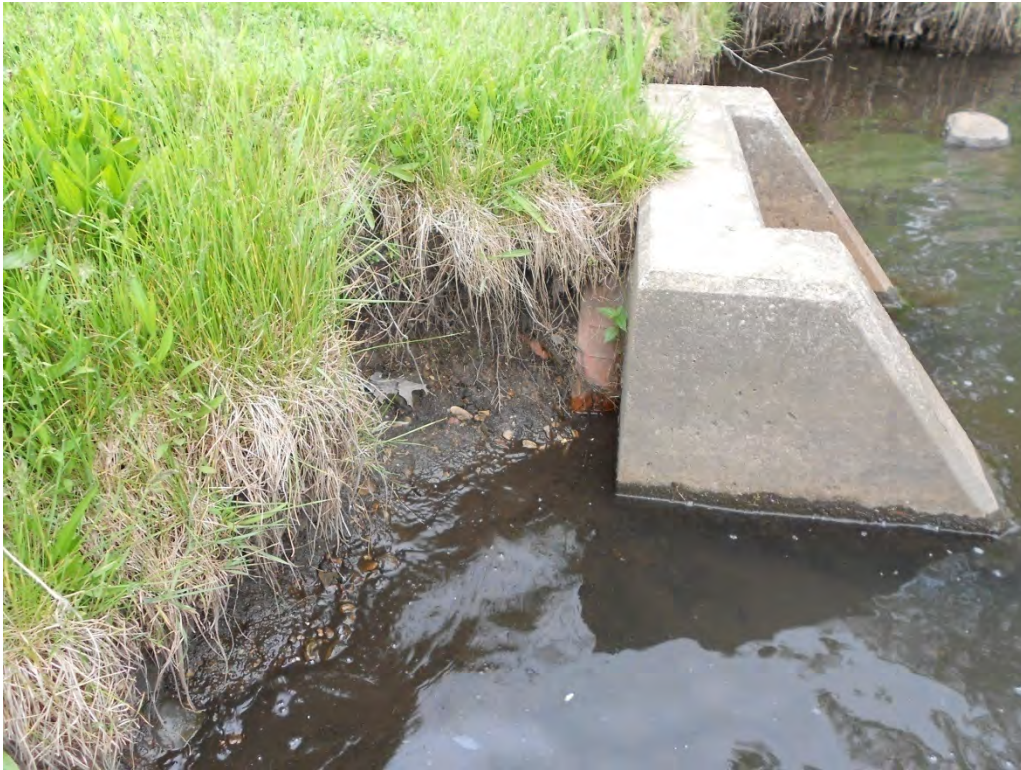
- Severe bank erosion has exposed the pipe behind the headwall on the south side and nearly exposed it on the north side. The bank is cut approximately 2' behind the headwall.
- No significant deterioration was noted on the pipe or headwall.

Bank erosion exposing clay pipe on the south side

- Install a cofferdam to protect the structure and allow for dewatering. Provide approximately 2' clearance from the headwall.

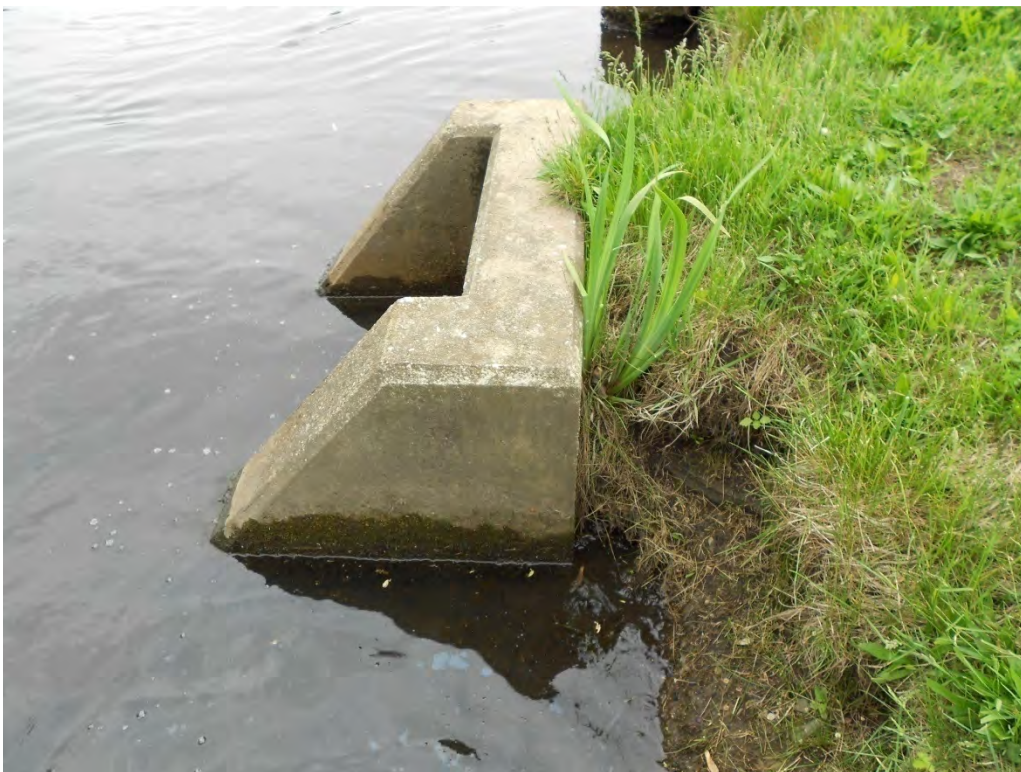
Bank erosion around north side of headwall

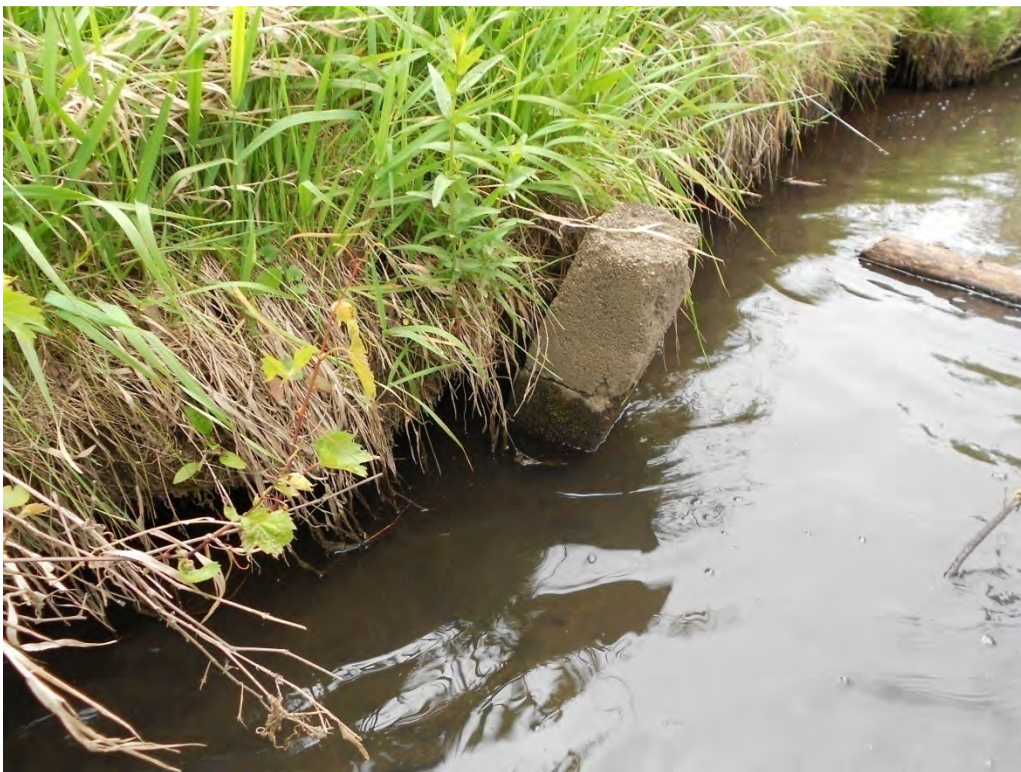
Post leaning severely toward the channel

- The purpose for the post is unknown and it can likely be removed in conjunction with sediment removal operations.

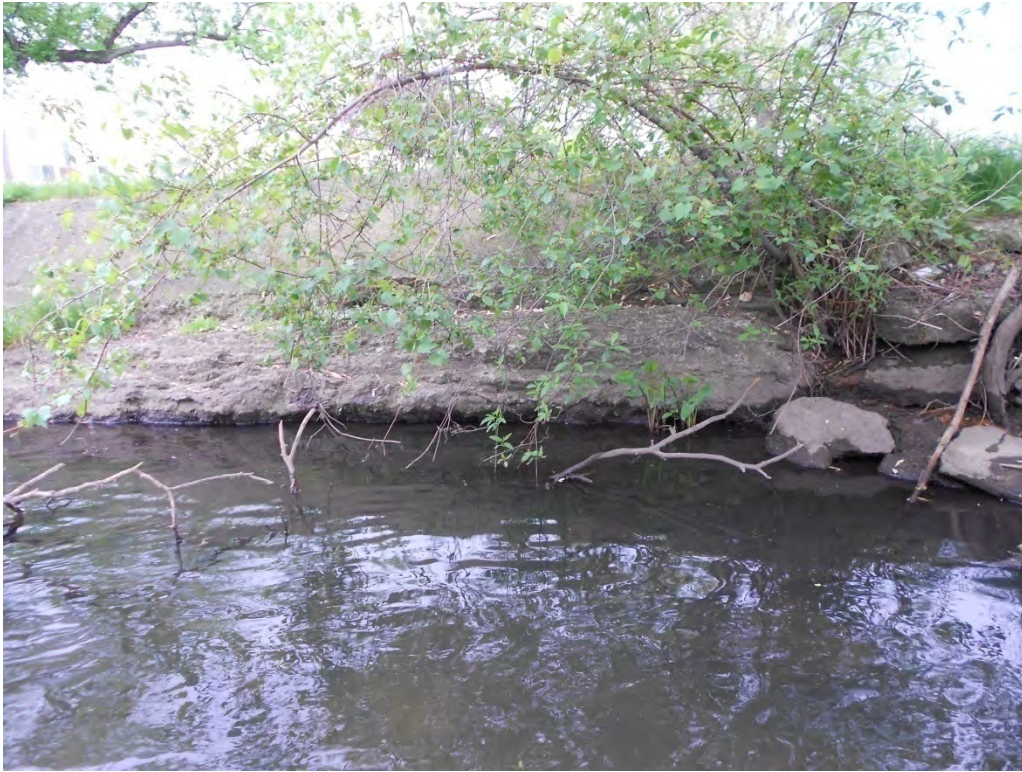
- The concrete is abraded at the waterline with severe cracking and settlement of the slabs.
- There is significant vegetation growth between the slabs and through cracks.
- There is a significant amount of failed rubble in the channel along the toe of the bank.

View of the structure from the channel

- Remove and replace the slabs as required to facilitate cofferdam installation and sediment removal.

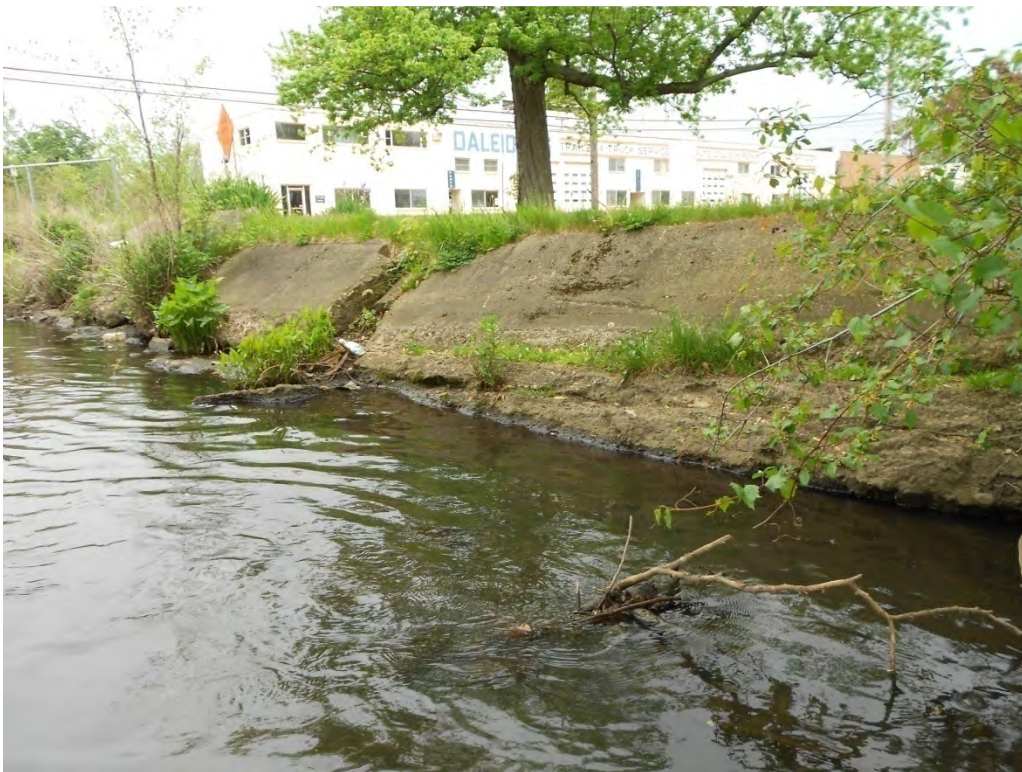
Vegetation growth through the structure

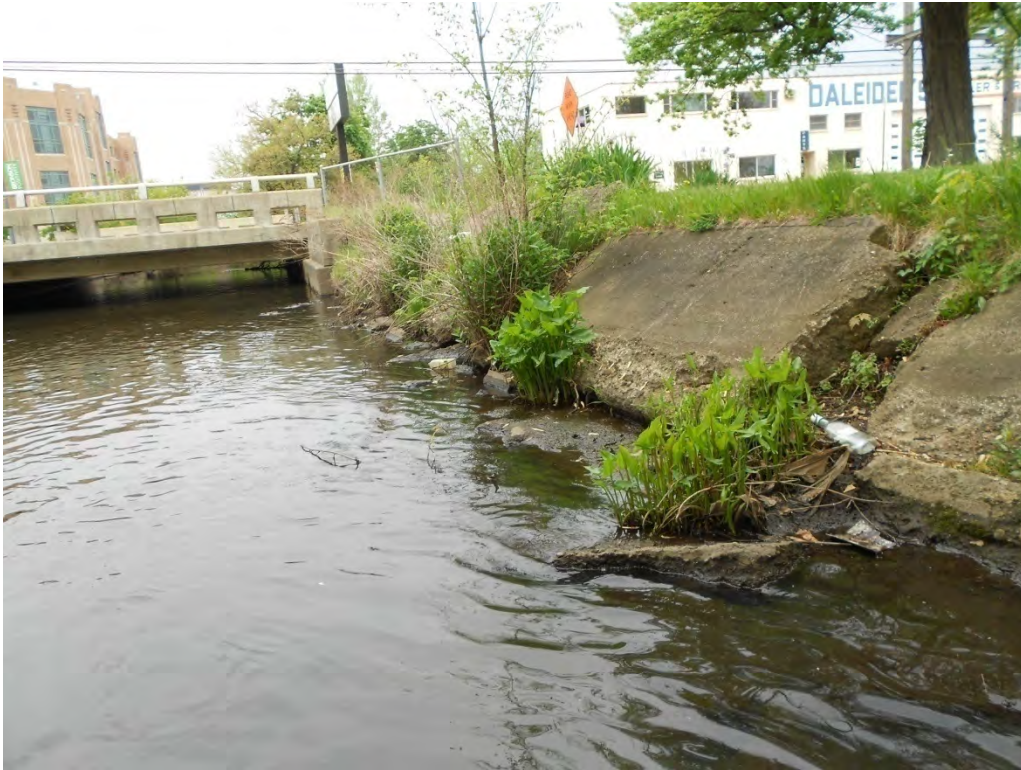
Vegetation growth through the structure

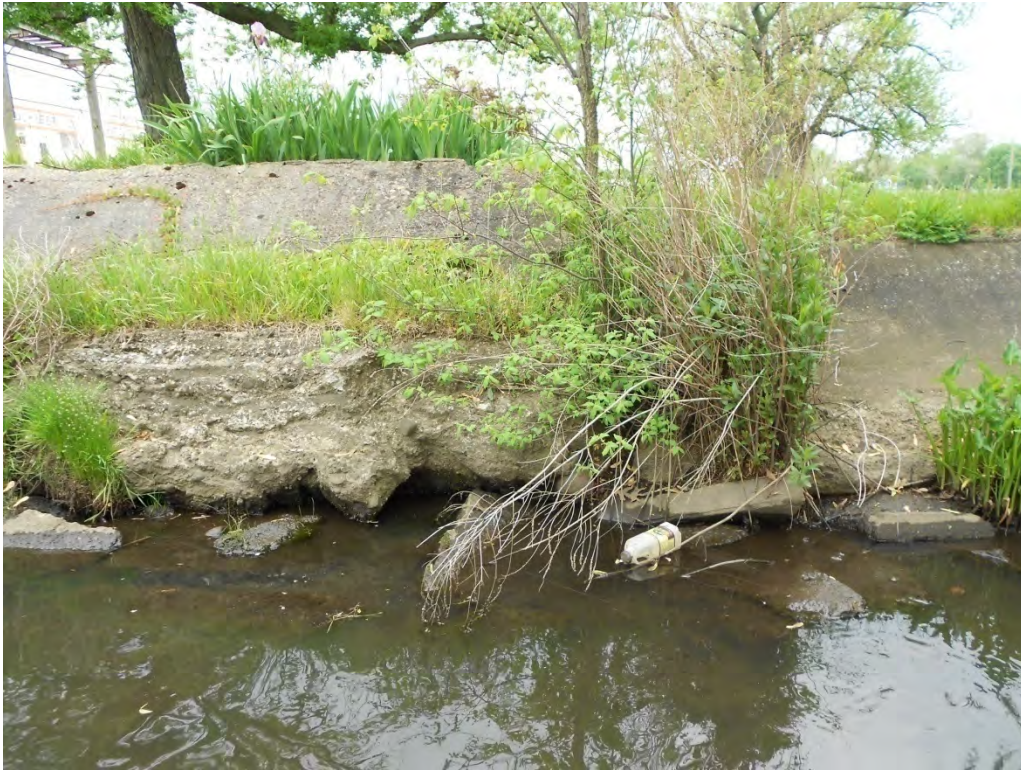
Vegetation growth and abrasion along the waterline

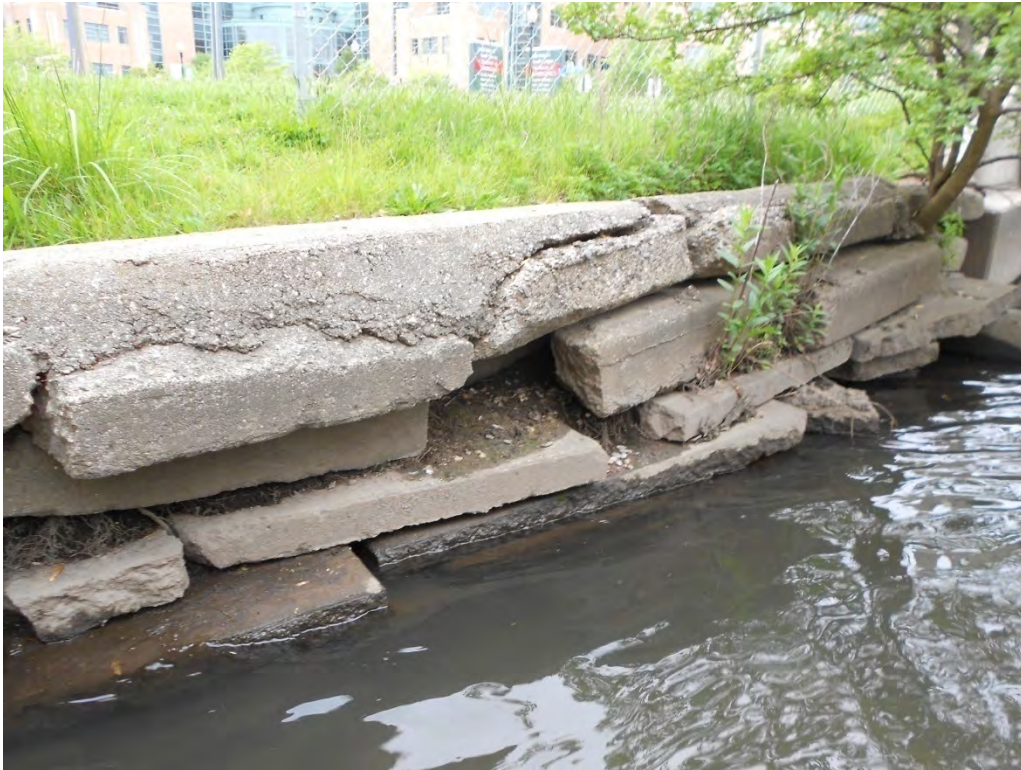
- The 12" concrete storm sewer outlet is severely abraded/spalled exposing the steel reinforcement.
- Slabs have severe cracking and settlement, approximately 2" at the southwest concrete wingwall of the Vine Street bridge.
- There is significant vegetation growth through the wall.
- The south end has severe bank erosion with a sink hole behind the wall.

Gaps and vegetation growth in the wall

- Remove and replace the slabs as required to facilitate cofferdam installation and sediment removal or extend the cofferdam around the structure with approximately 4' clearance.
- Protect the storm sewer outlet with a cofferdam to allow for dewatering. Because of its proximity, the cofferdam will likely be part of the cofferdam for the Vine Street bridge.

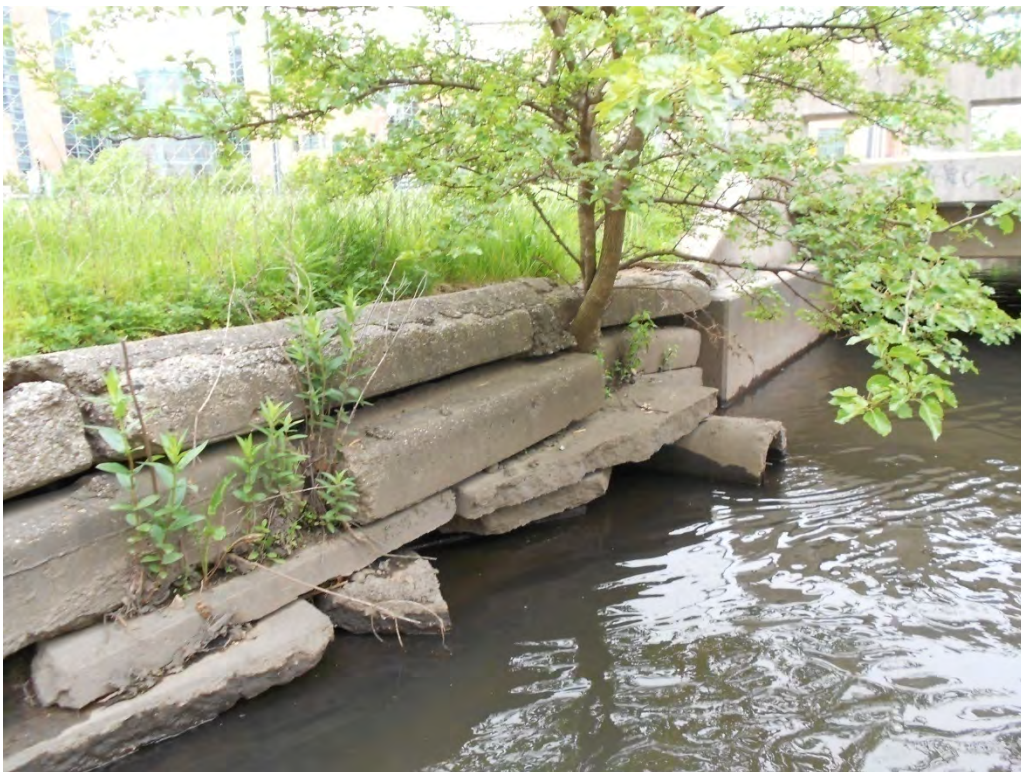
Tree growth in north area of the wall near the storm sewer outlet

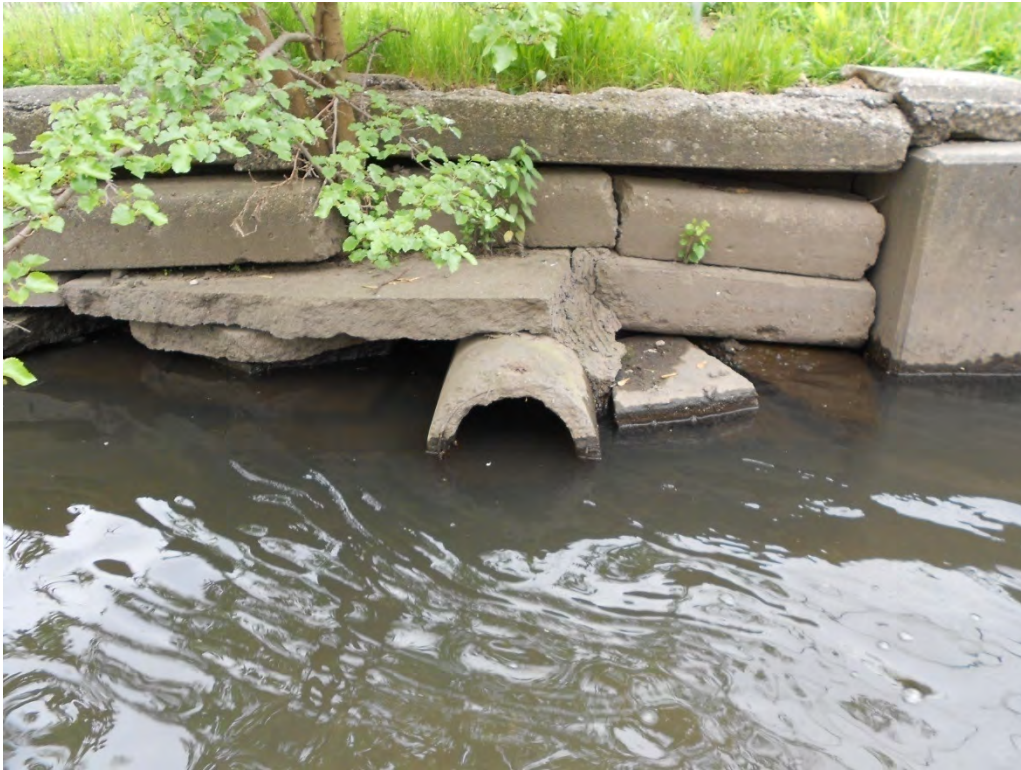
Storm sewer outlet through the wall

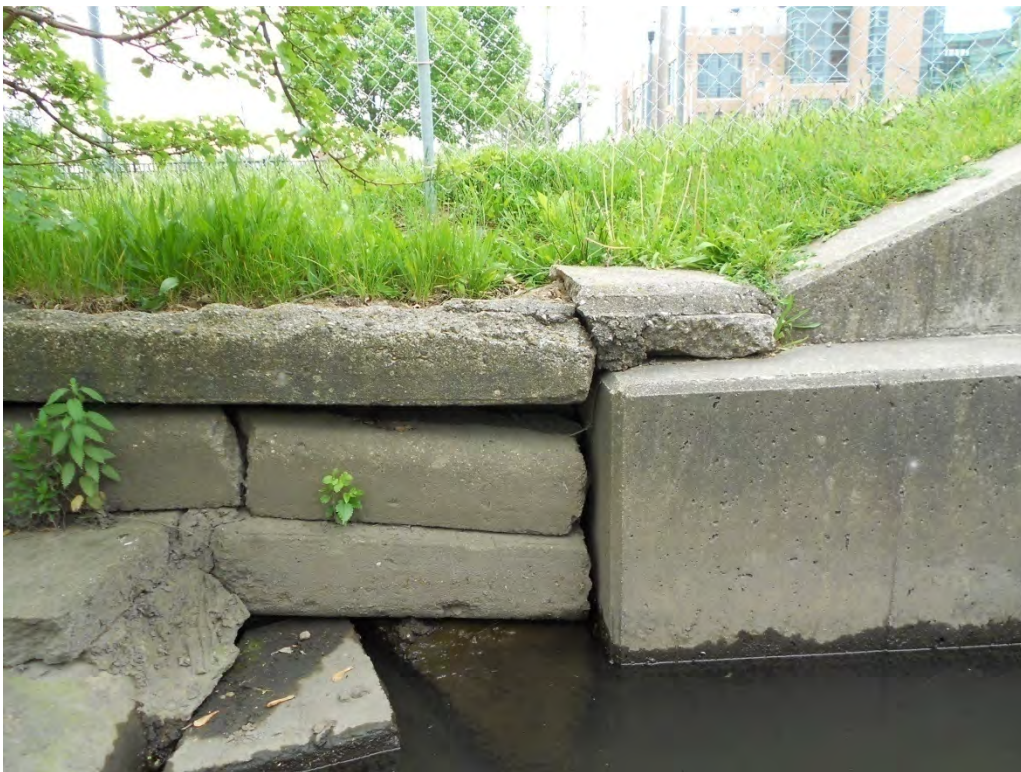
Settlement of the concrete slabs at the Vine Street bridge

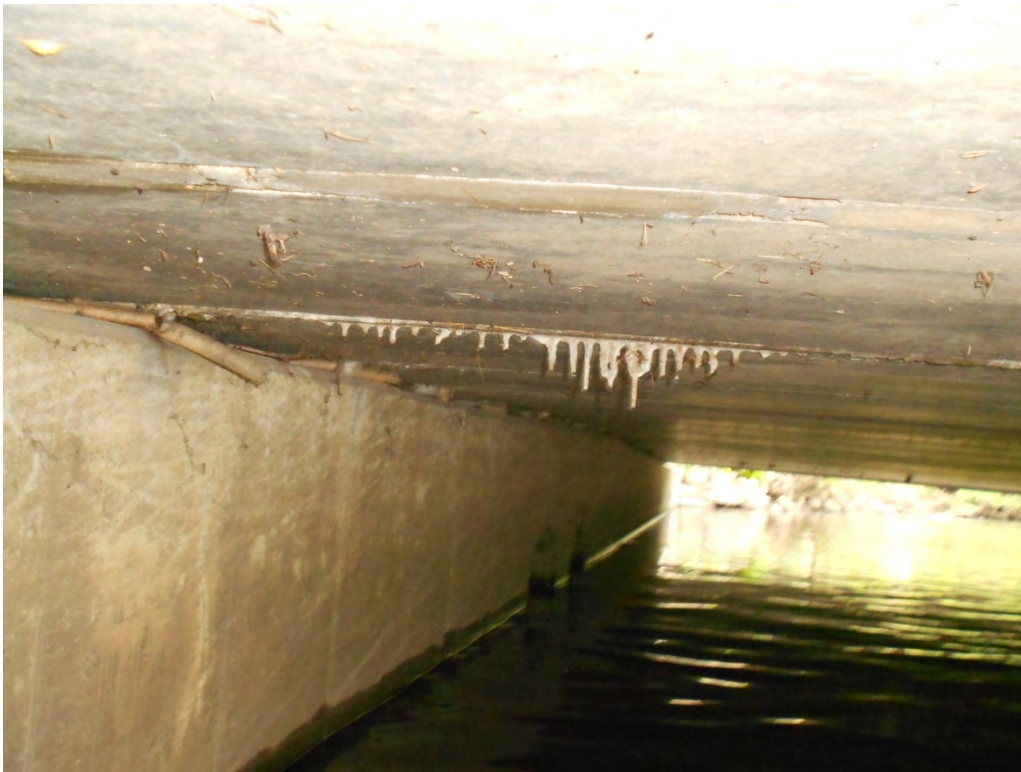
- Efflorescence and stalactites were noted along several box beam joints.
- The banks are protected by concrete rubble walls in the southeast and southwest.

Efflorescence and stalactites along box beam joint

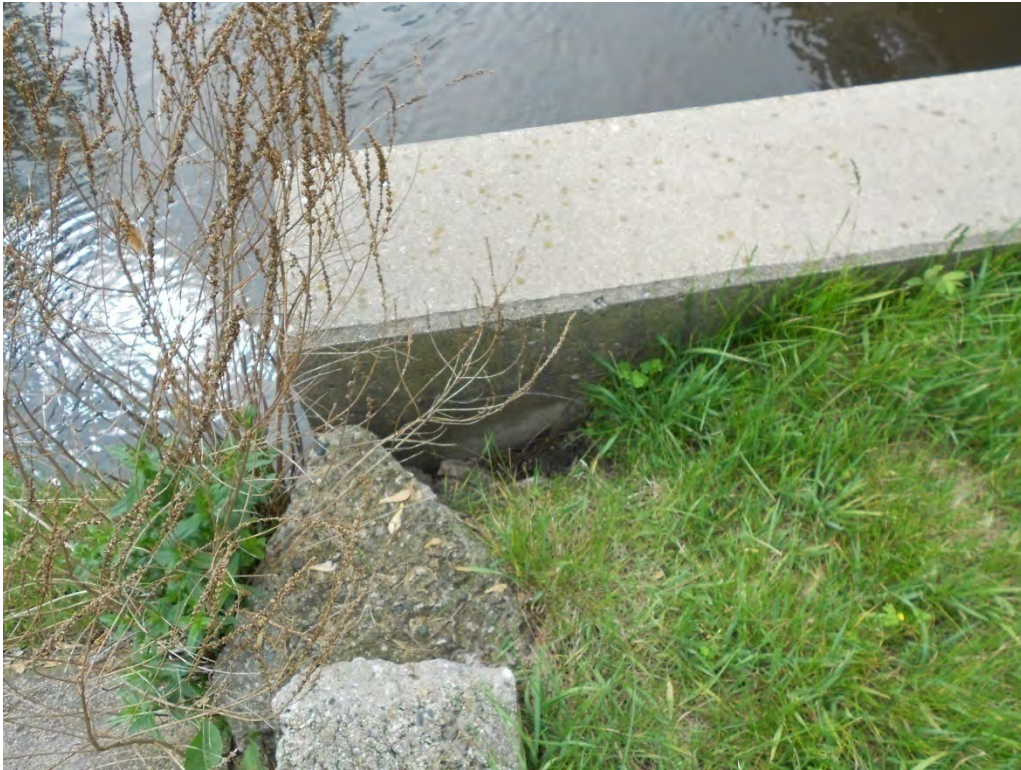
Bank erosion around the southeast abutment

- Because of the bridge's depth of footing and pile support, this structure will not be impacted by the sediment removal operation itself or vibration from sheet pile cofferdam installation. However, the adjacent concrete rubble walls are more susceptible to damage from vibration and likely do not extend below the bottom of the sediment excavation. Therefore, these structures should either be removed and replaced in kind or protected with a sand bag cofferdam. A 4' clearance between cofferdam and face of wall is recommended.

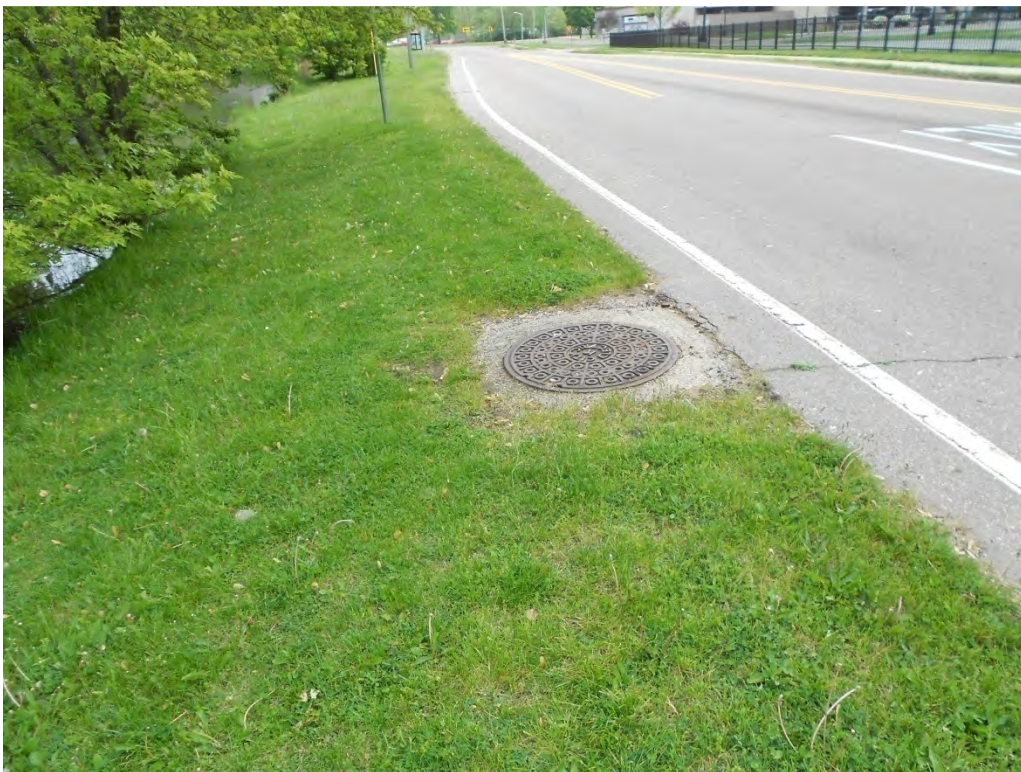
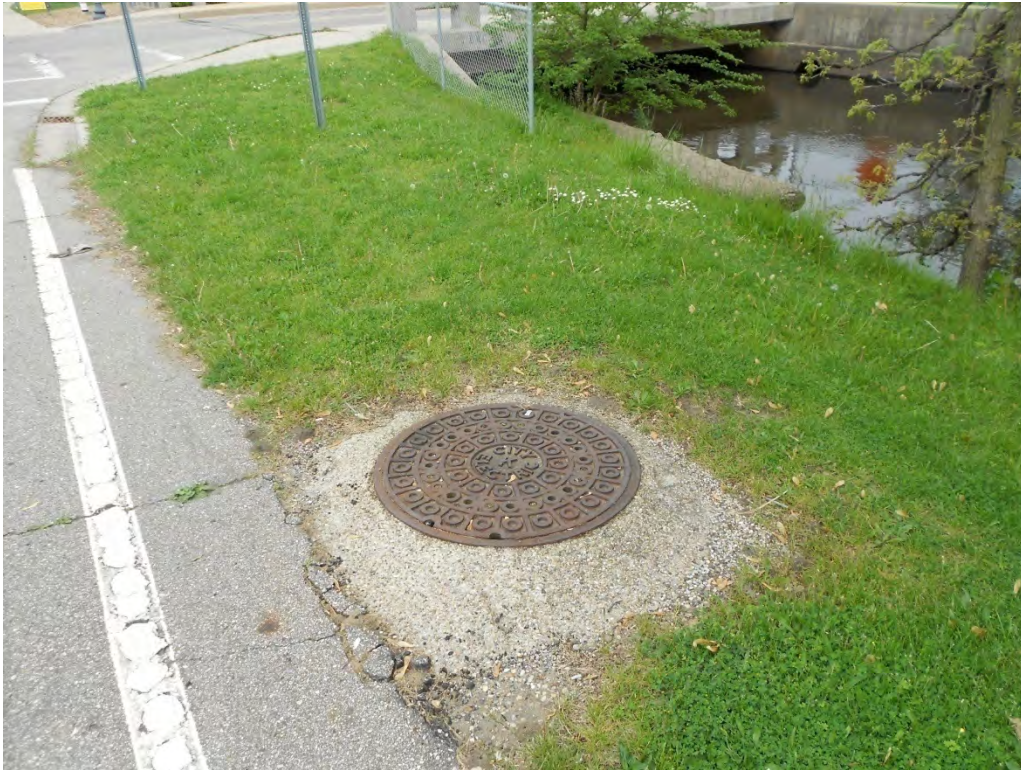
Electric vault in the southwest

Electric vault in the southwest looking northeast

- During evaluation, equipment was not available to access the electric vault in the southwest quadrant along Jasper Street. Mapping of the area's electric facilities have been requested but are not yet available. Therefore, it is recommended that the vault be opened prior to work in the area to check whether there are underground facilities suspected of crossing beneath the channel in this area. Utility mapping will be reviewed when it is received and an update provided.

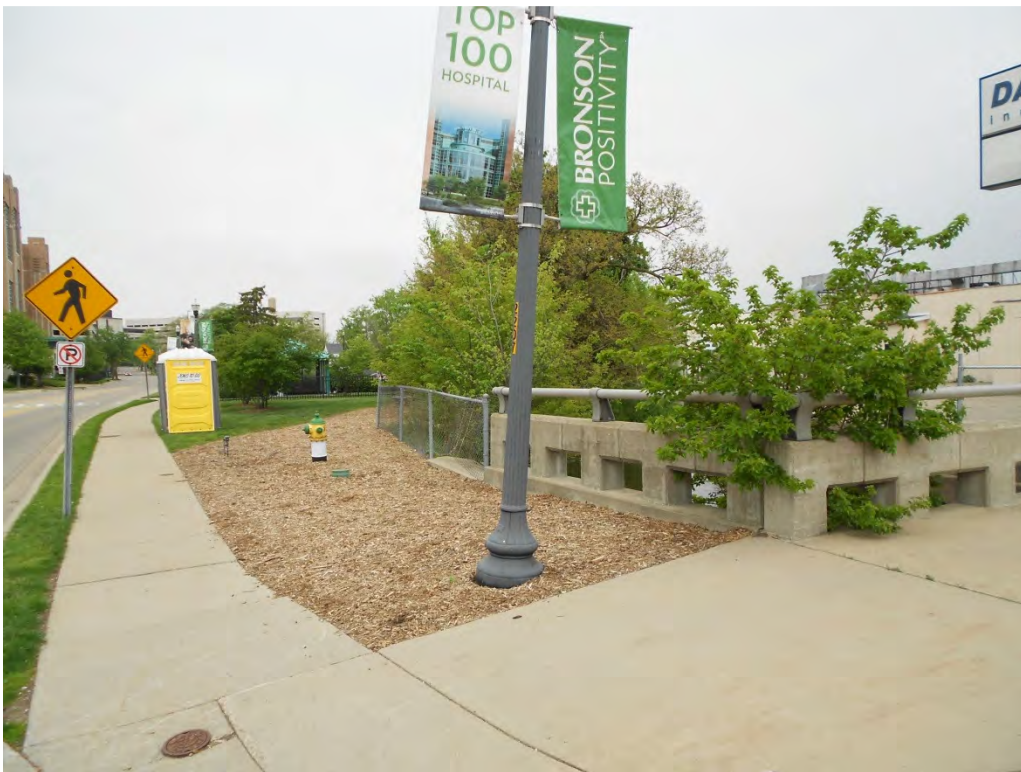
- A water main gate valve was noted in the northwest sidewalk. The water main crosses Portage Creek suspended along the north fascia.
- There is a light pole in the northwest, which is leaning, along with a fire hydrant and irrigation equipment.

Leaning light pole in the northwest

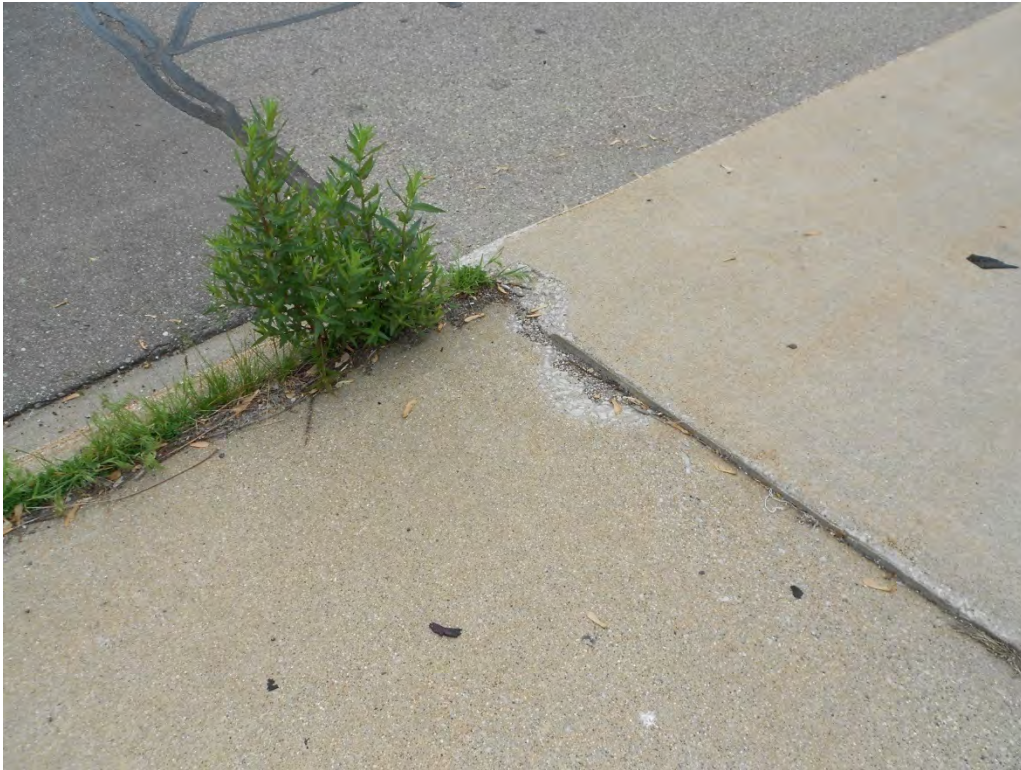
- Minor spalling was noted in the northeast sidewalk and the approach sidewalk has settled approximately 1".
- Severe to critical spalling to steel was noted on a railing post near midspan, north side.

Settlement and spalling of the northeast sidewalk with vegetation growth

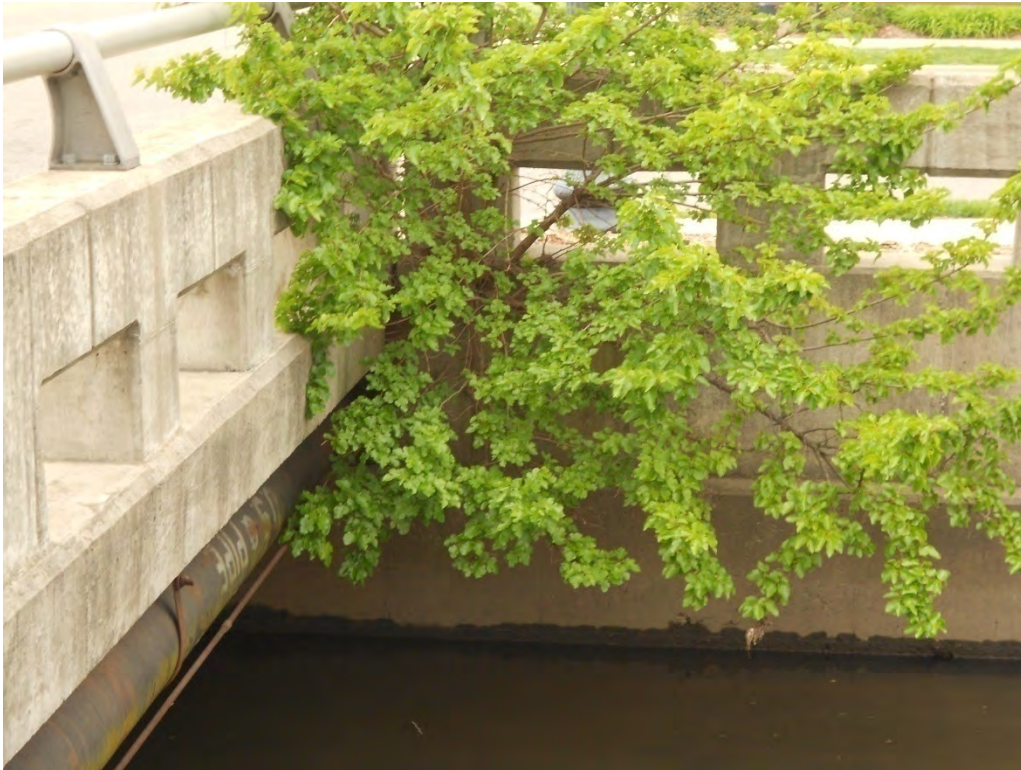
Brush growth on the northwest abutment

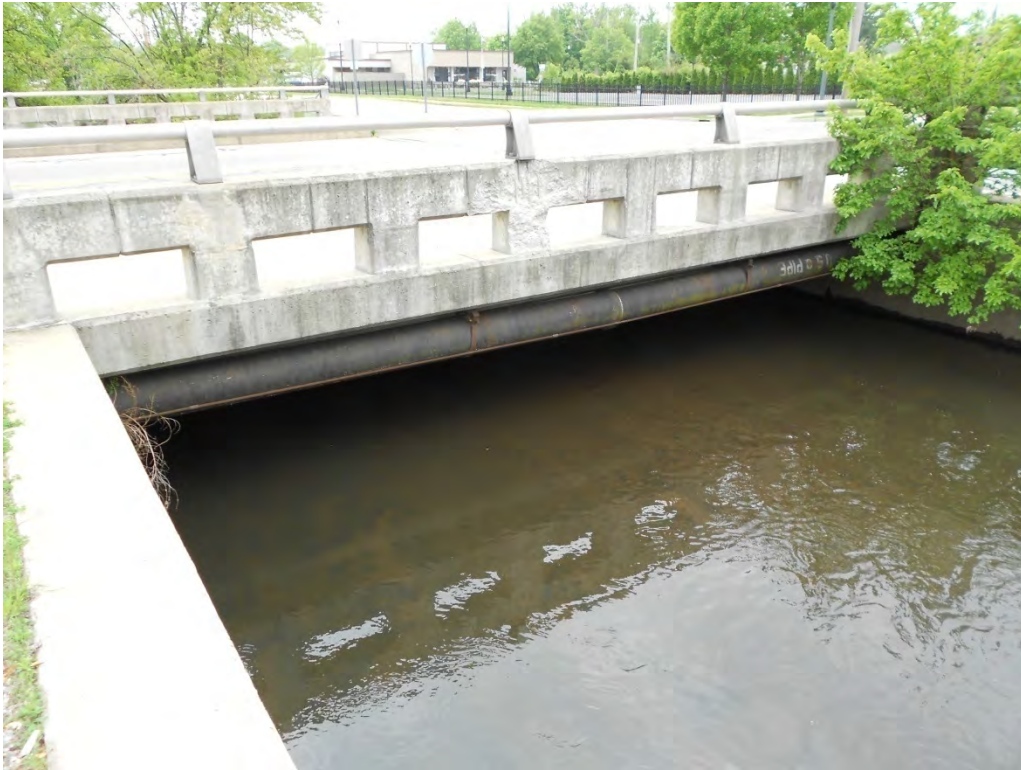
Water main crossing on the north fascia

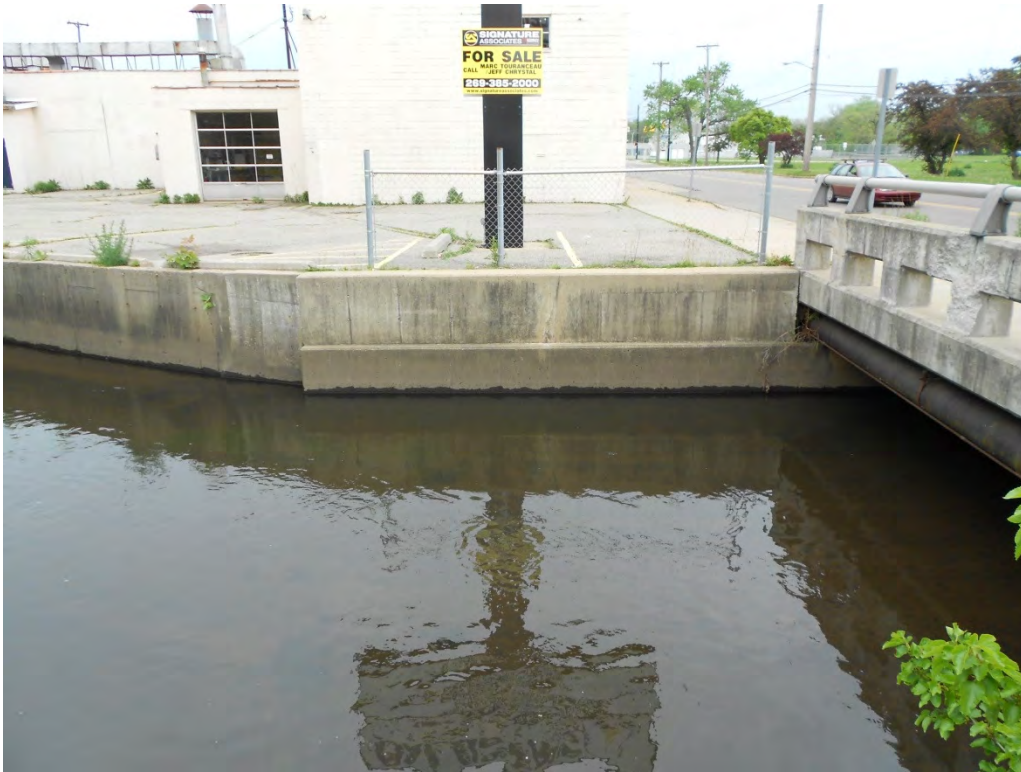
View of the northeast concrete abutment with concrete retaining wall beyond (left)

- The concrete retaining wall in the northeast is less susceptible to damage from vibration and likely has a footing at least several feet below the bottom of the channel. A sheet pile type cofferdam should be acceptable with a 4' clearance, however, the gap between the wall and the end of the sheet pile will need to be sealed with sand bags or similar, therefore a complete sand bag wall may be preferable.
